TECHNICAL REPORT SL-92-14

## DETERIORATED CONCRETE FROM LINER OF WIPP WASTE SHAFT

L. D. Wakeley, T. S. Poole, J. P. Burkes

Structures Laboratory

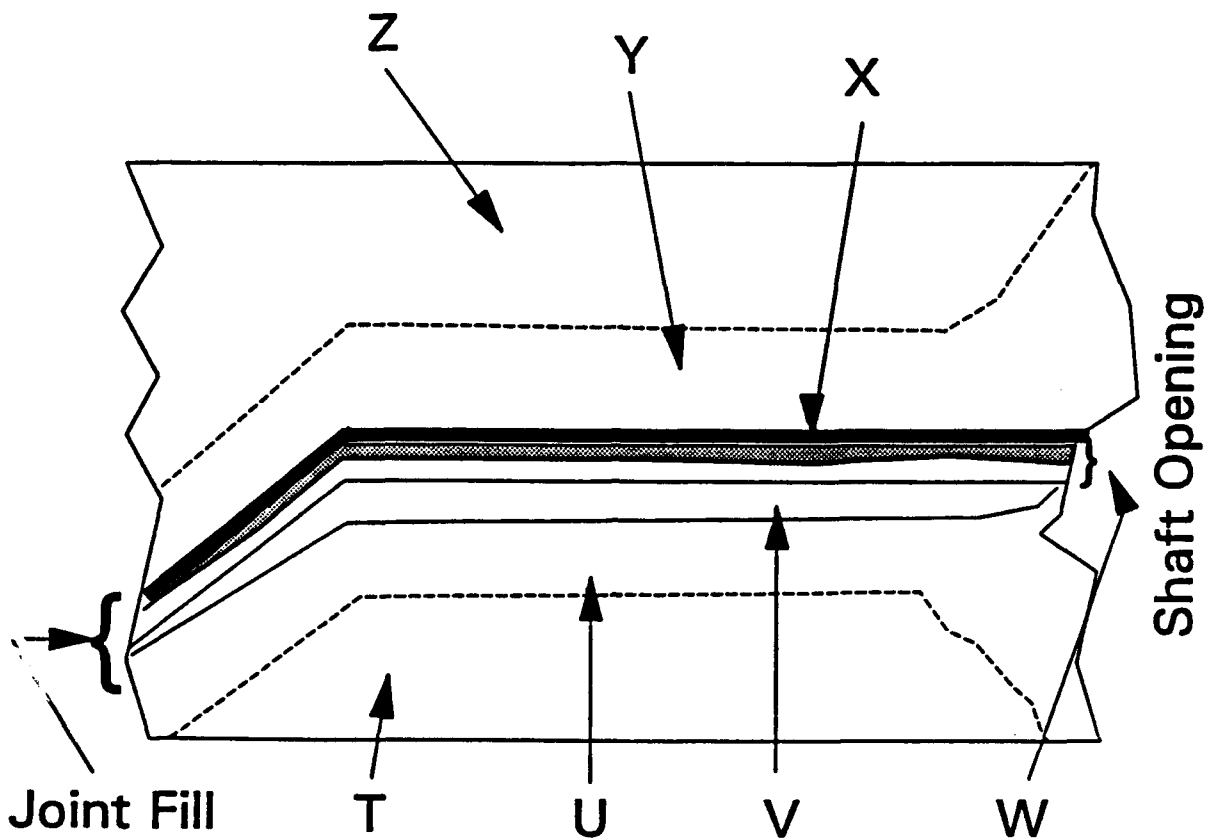
54. The deteriorated layers were almost exactly parallel to the joint and thicker in the lift below the joint (up to 50 mm thick vs. 20 mm or less for the upper concrete). The shaft-opening end of each core segment also was discolored and apparently deteriorated, which was taken to indicate deterioration by interaction between moving brine and concrete components. Both cement paste and aggregates were affected, indicating multiple mechanisms of degradation. The greater thickness and severity of damage below the joint was attributed to a difference in the original concrete; or a simple effect of gravity causing the brine to penetrate the concrete more, downward; or both.

60. Individual coarse aggregates straddled the boundary between discolored and "good" concrete (between U and T on Figure 2). These aggregates tended to break along this boundary when probed with a dental pick, rather than break out of the paste. In fact, each individual aggregate broke along the line where the discoloration stopped, and fractured into many parallel pieces above this interface (the portion that was within U). That portion of each aggregate that was within the "good" paste (T) remained intact and bonded to the paste. Recall that this boundary is not from casting, but is apparently a front representing the extent of chemical alteration. Their fracturing showed that the aggregates, too, were softened by chemical attack.

Figure 2. Lateral view of external features of 834-1 and 834-2. Cores are approximately 15 cm long

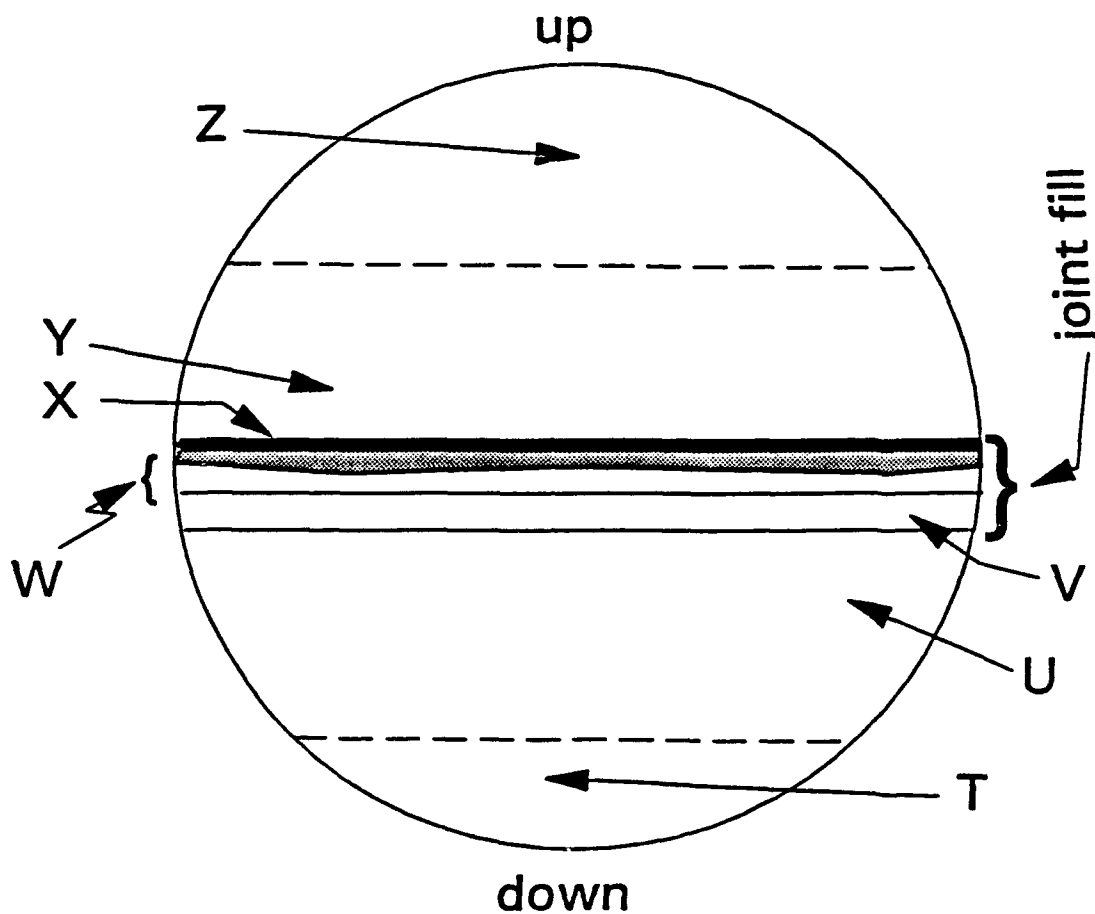
Figure 3. Cross section of 834-1 and 834-2.  
Cores are 7.5 cm across

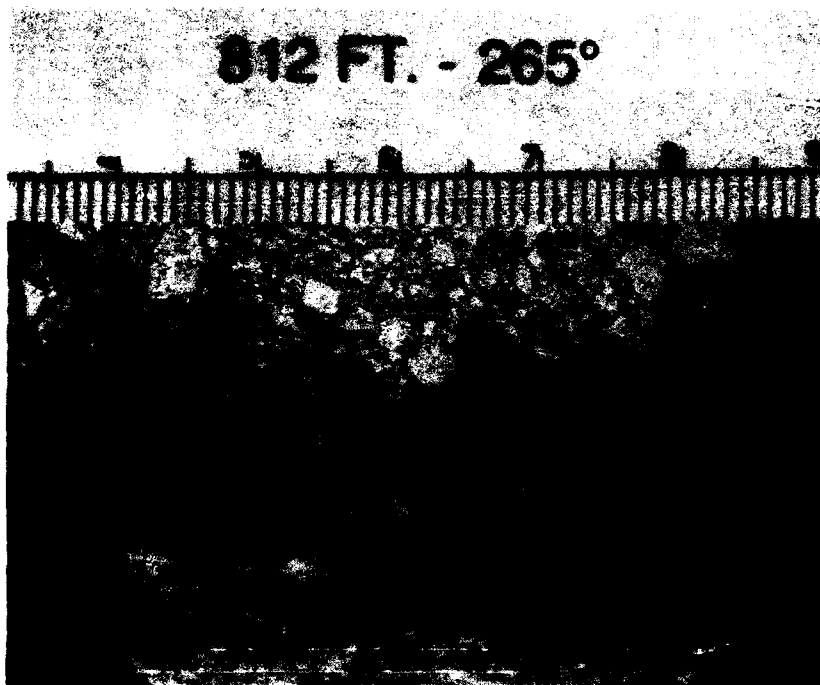
Figure C7. Core 812-265 (WIPP-2 DC-2). View of three distinct conditions of the concrete liner exposed in waste shaft

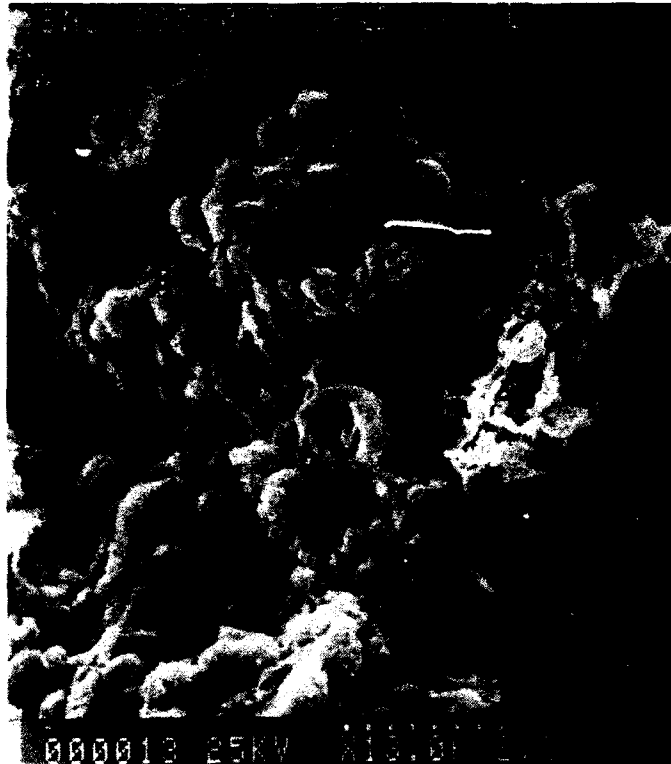
Figure C17. Grab sample 890-085 (WIPP-2 SM-6).  
Aggregate surface that was exposed to brine
